**Flood Control Project Maintenance
Levee Inspections**
LMA District Cover Sheet
Spring 2017 Levee Inspection Results

American River Flood Control District

Spring 2017 Levee Inspection Results

Waterway			Bank	Unit Miles
Unit No. 01 Arcade Creek			Left	2.08
	Spring (March - May)	Summer (June - August)	(September - November) Fall	Winter (December - February)
Unit Maintenance Rating (Fall Only)				
Date of Inspection	3/15/2017 - 5/3/2017			
DWR Inspector	Maksim Khashchuk			
Accompanied By	Ross Kawamura ARFCD

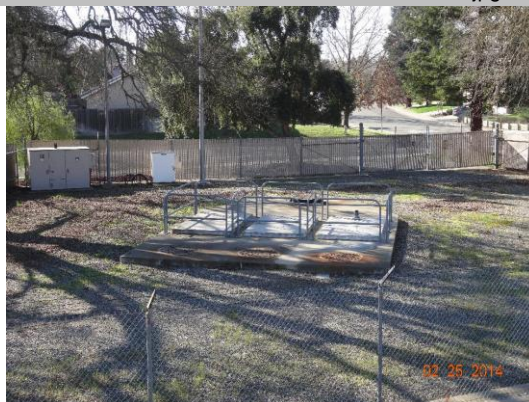
Photo 2 of 3 : UCIP_SP_2017_30540_56230.jpg

Comment Code					
Inspector Comment					
FS_ID:30540 DS_ID:24829 EP_NO: N/A Repair Type: Non-Urgent Crossing Status: Indicator Found UCIP Comments: Unable to confirm pipe size--need to contact owner to obtain additional information on crossing. FIELD_STRUCT_DESC: [SRCSD Facility N16 NE Siphon Outlet] 2 of 3: 48-inch reinforced concrete (RC) drainpipe through the levee at 11.0 feet below crown. Pipe crosses levee at an angle. Sacramento Regional County Sanitation District (SRCSD) Facility N16 NE Siphon Outlet located on landside (LS). Facility is fenced off. Inside facility are 3 concrete boxes with 3 manholes. (Permit No. 12144-1978, SRCSD and 12144-A-1983, SRCSD for cathodic protection) FS Date: 2/25/2014

Manholes visible on landward side.
